# Gale Tree Consultancy

## Tree Condition Report

Plaistow & Ifold Recreation Ground

Ref: TCR/646/25

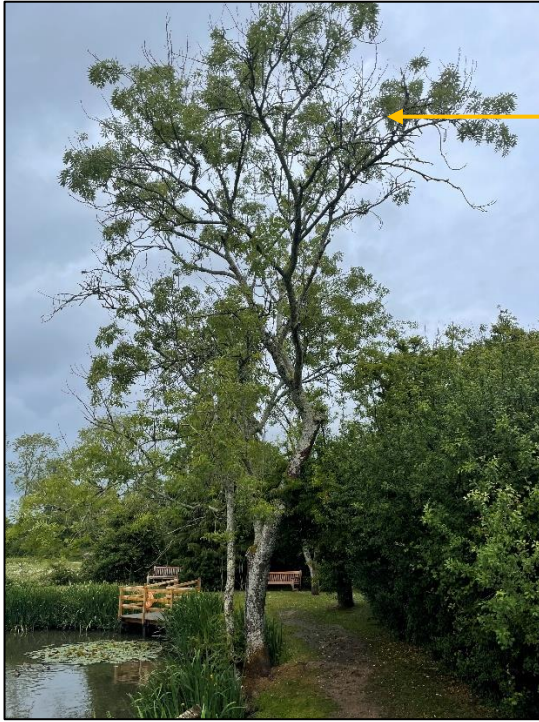
- Two Common ash trees were recorded as having advancing symptoms of Ash Dieback
- Ash dieback (ADB) (*Hymenocyphus fraxineus*) inhibits water supply and as such causes leaf loss, lesions on the branches and stems (of younger trees) and ultimately results in the decline of the trees crown

T1/428 Common ash showing advancing symptoms of Ash Dieback and deadwood over the path

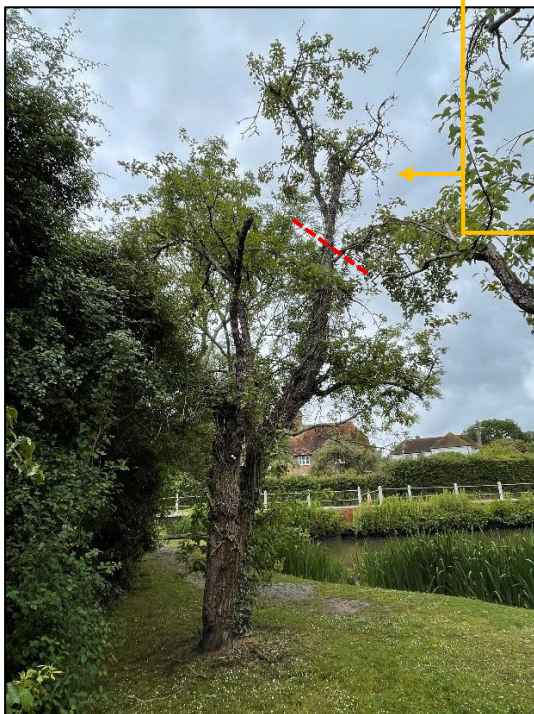
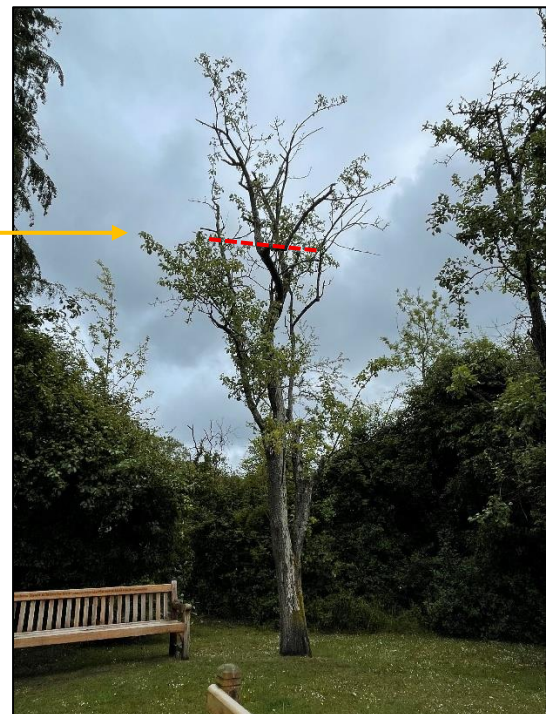
- I do not consider there a need to remove the tree based solely on the presence of the fruiting body
- Three Pear trees have decay in their stems and decline forming in their crowns

T2/429 and T3/430 Pears showing declining crowns with the red dashed line indicating the approximate line to reduce them to

- A recommendation to reduce them has been made to reduce the loading on the lower stem area whilst retaining their character
- Ivy has been recorded on three trees where it is growing back from the previous recommendation to sever it
