# Gale Tree Consultancy

## Tree Condition Report

Plaistow and Ifold Parish Council

Ref: TCR/643/25

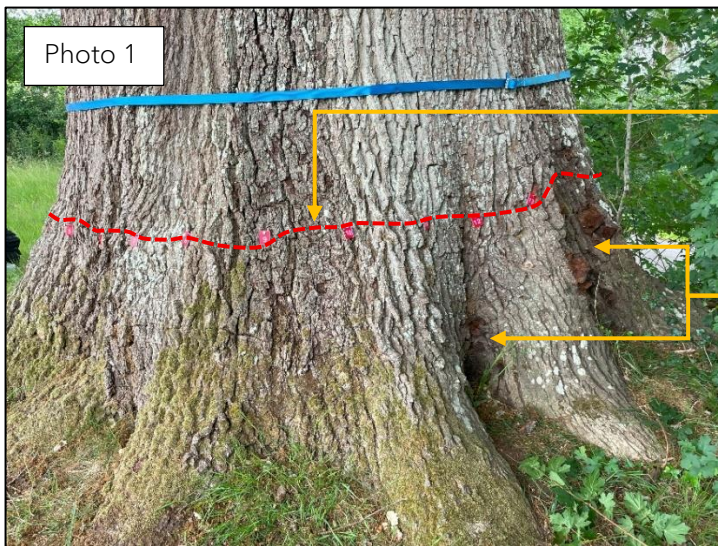
View from the west side of the tree

Height of assessment c.80cm above ground level

MP1 located on the north side of the stem

Note the attachment points of the decay fungus *Pseudoinonotus dryadeus*

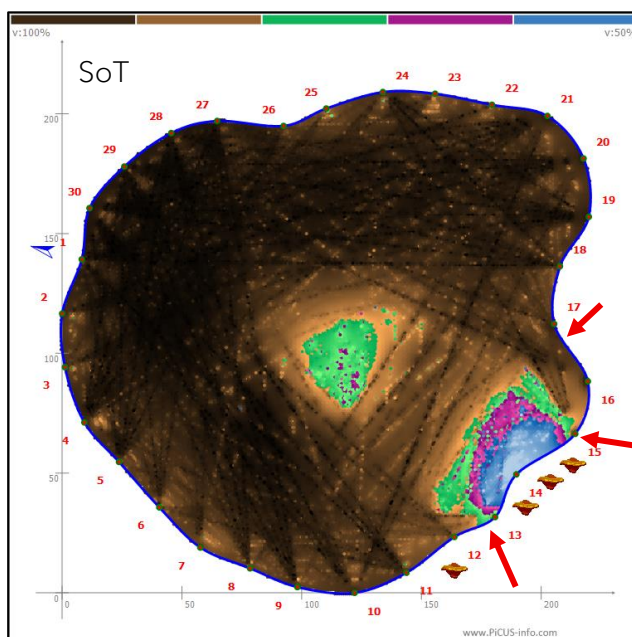
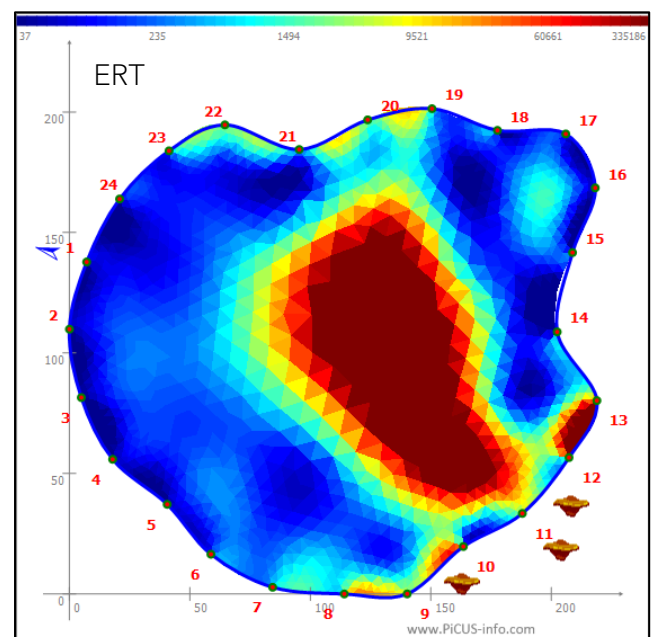
- The tomogram indicates an area of high sonic velocity, and as such sound wood, across the level of assessment as shown by the brown colour present
- However, the area of blue adjacent to MP13, 14 and 15 shows an area of low sonic velocity, and as such decay; the green colouration in the centre of the stem shows an area of decay developing
- Please note, the fungal symbols reference the location of the *Pseudoinonotus dryadeus* brackets, and the tomograms have been rotated to match Photo 1

- The ERT result shows an area of reduced electrical resistance, as shown by the red colouration, within the central area of the stem which extends outwards towards the southwest side of the stem; this suggests an area of decay/dysfunction is present
- To confirm the tomogram, the Resi PD400 was used in three locations at the level of assessment – please see the red arrows on the SoT result on the previous page and the drill traces overleaf
- A further two drill assessments were performed on the southern buttress root

- The SoT result shows an area of low sonic velocity, and as such decay, on the southwest side of the stem, consistent with the locations of the *Pseudoinonotus dryadeus* attachment points; it also shows an area of decay beginning to establish within the central region of the stem

- The ERT result confirms this but also shows this to be larger with a wider area of decay and dysfunction within the central region of the stem – this is to be expected considering its ability to assess beneath the SoT plane and the mode of the fungus

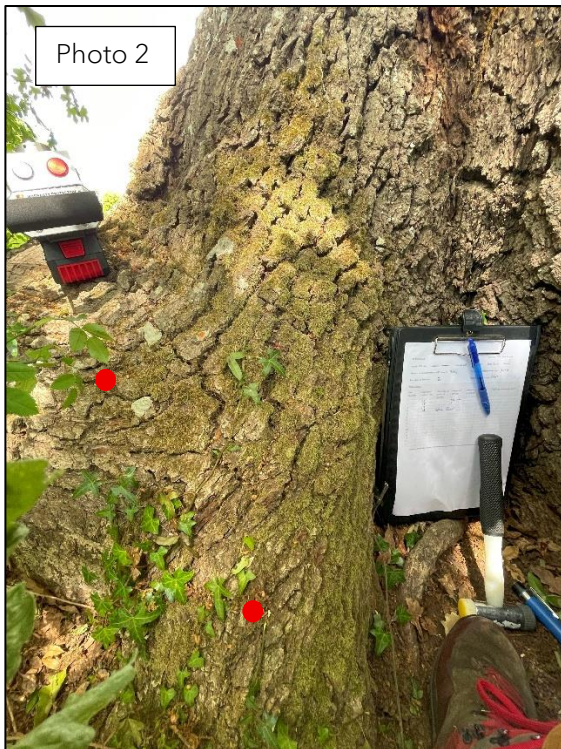
View from the south side of the tree

Locations of the two drill assessments on the southern buttress root

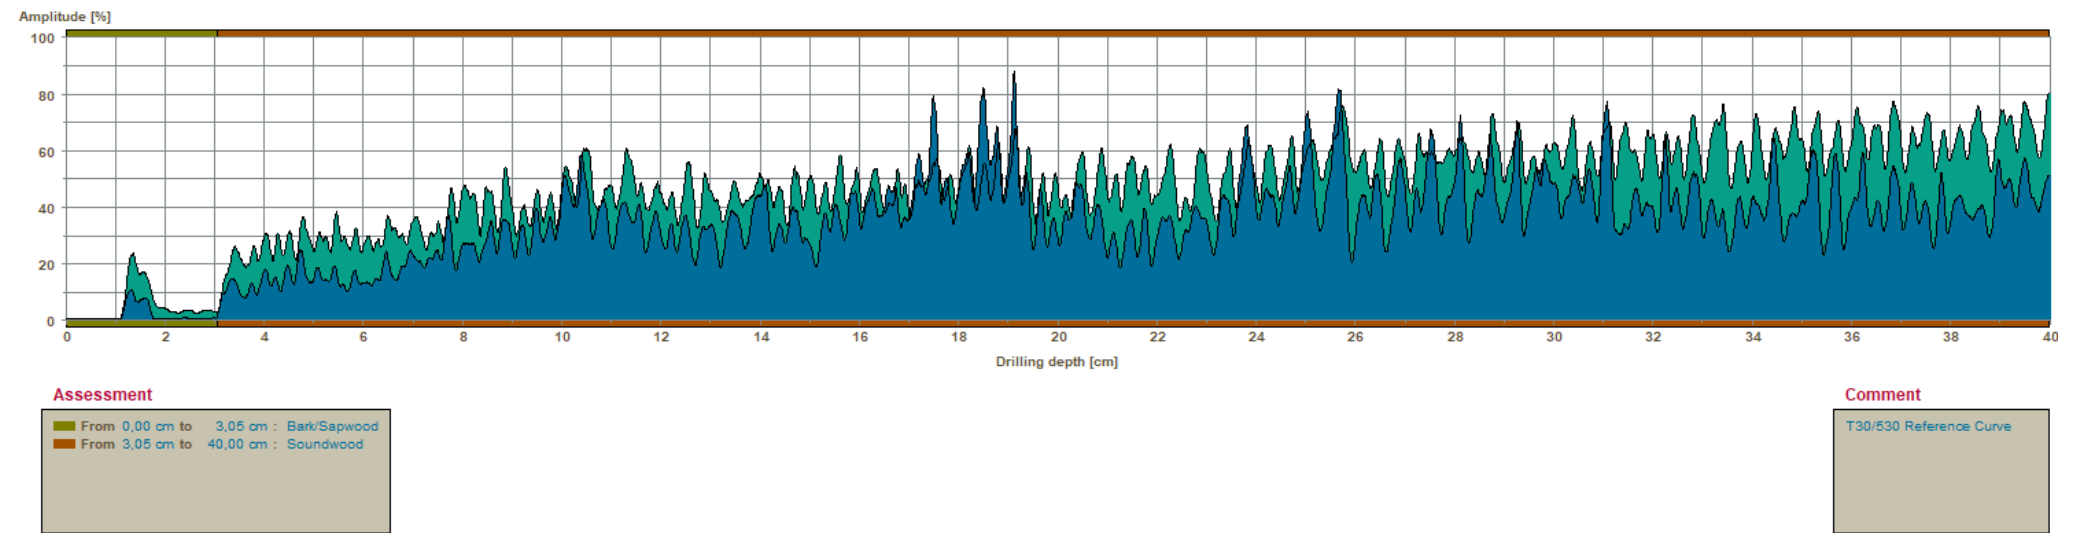
## Reference Curve at c.1.5m on the northwest side of the stem

- The reference curve is used to establish a baseline of what the sound wood looks like as a drill trace, and it shows a steady and increasing resistance to the needle drill confirming sound wood

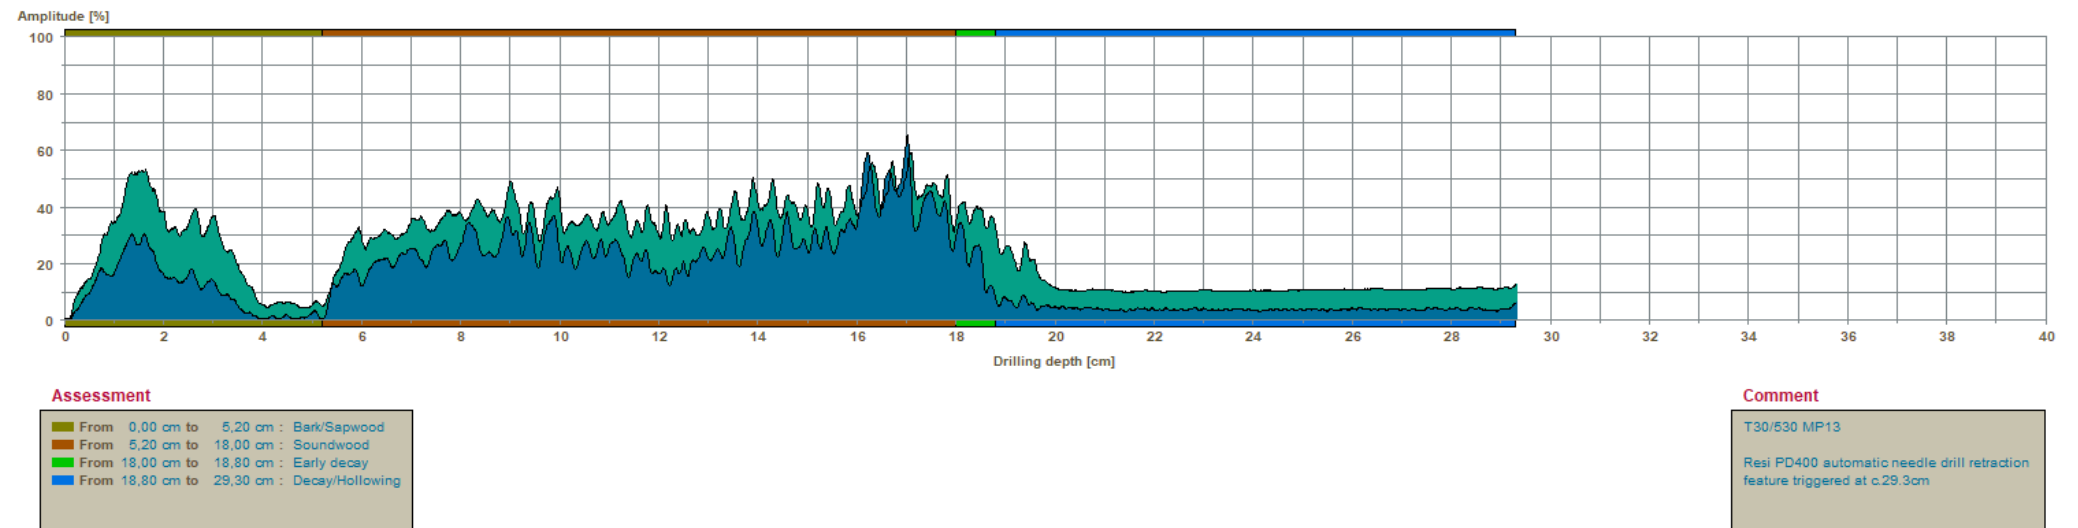
## Drill Trave 1 - MP13

- Drill Trace 1 shows the depth of sound wood is c.18cm before the drill enters an area of decay and hollowing. The unit's automatic needle drill retraction feature was triggered at c.29.3cm which occurs when either the drill has experienced no resistance for 15cm, or it has reached the opposite side of the cavity and begun to bend

- The drill trace shows a very slight increase at c.29.3cm which would suggest the needle drill began to bend and withdrew to reduce the risk of it snapping; this implies the cavity depth at this point is c.11.3cm

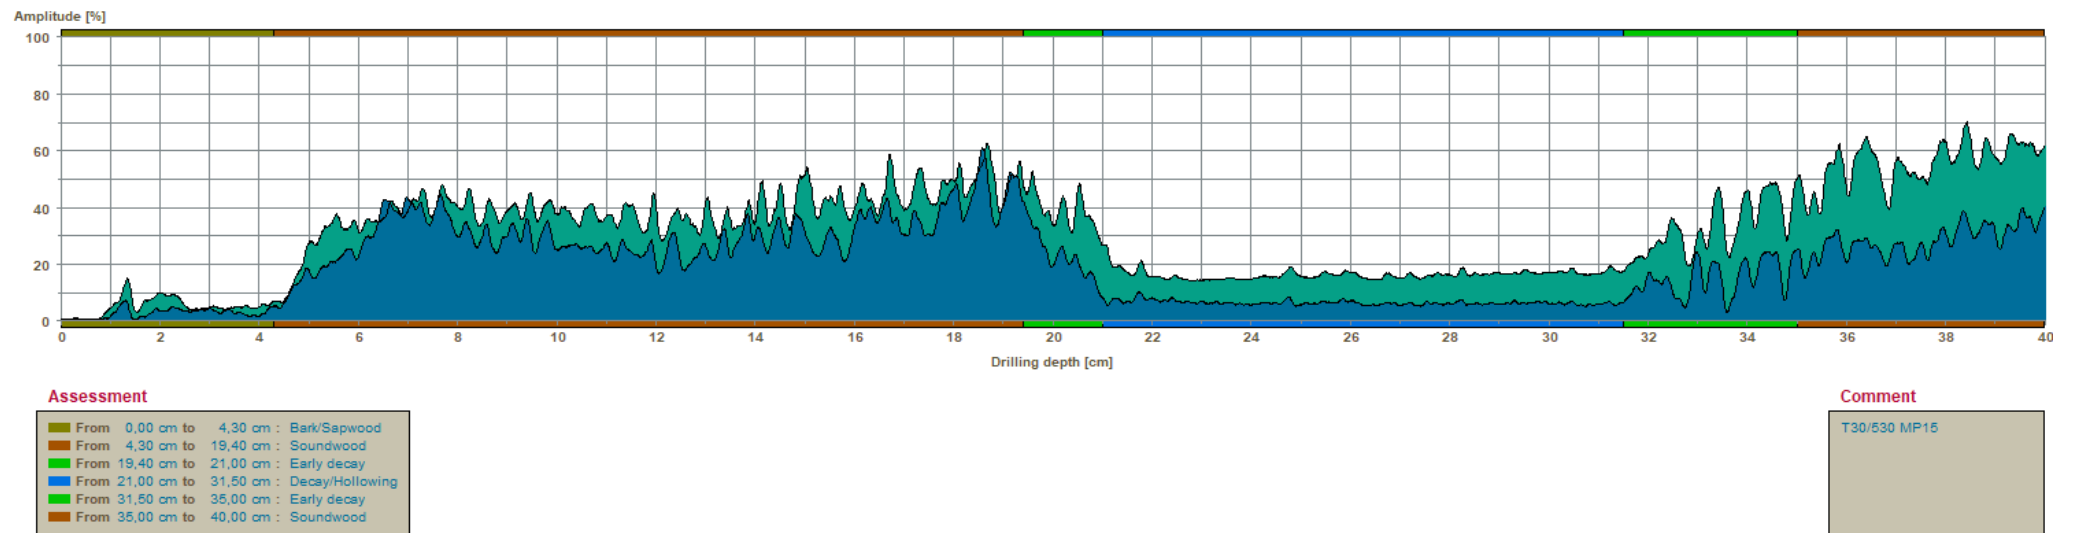
## Drill Trace 2 - MP15

- Drill Trace 2 shows sound wood either side of the decay/hollowing at c.21cm-31.5cm whilst Drill Trace 3 shows early decay forming at c.31.8cm
- Drill Traces 4 and 5 were performed on the southern buttress root and both show sound wood is present prior to the needle drill encountering drops in resistance and eventually decay and hollowing

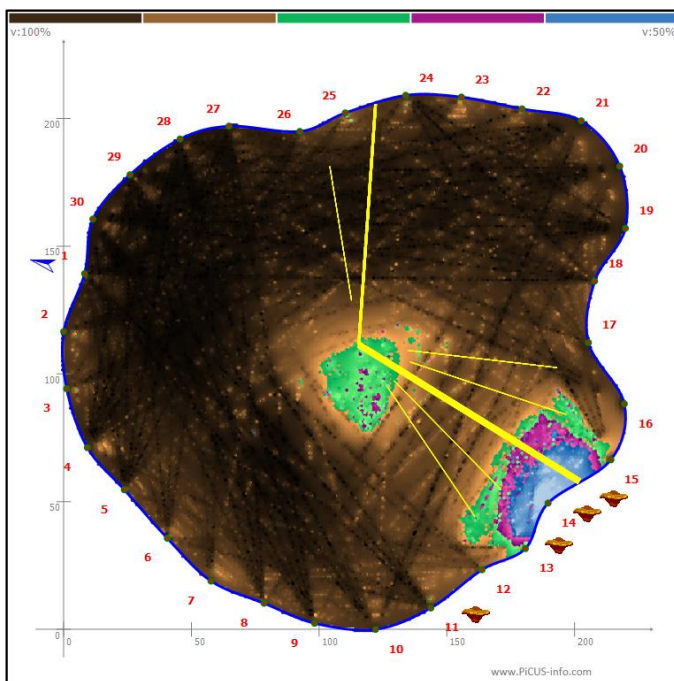
- The sound waves can be slowed and disrupted not only by wood exhibiting areas of decay, dysfunction or hollowing but also by deeply fluted and included buttress roots where the two opposing faces of bark act as a barrier; cracks and other internal features within the wood structure can also impede the sound waves. These areas are identified by yellow lines on the tomogram – see below:

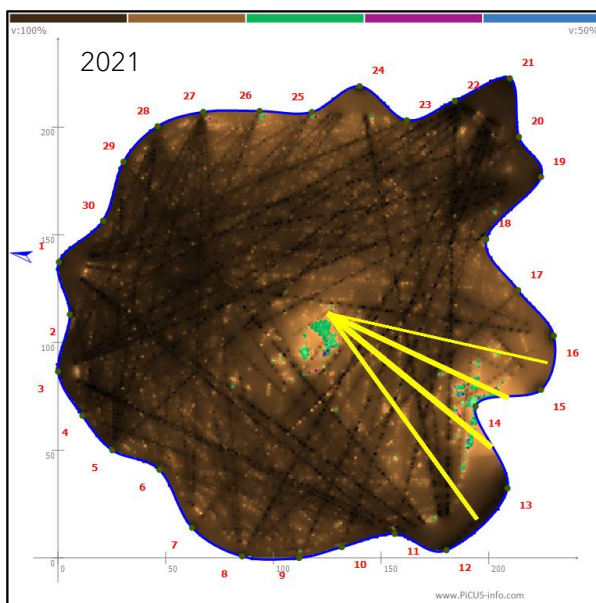
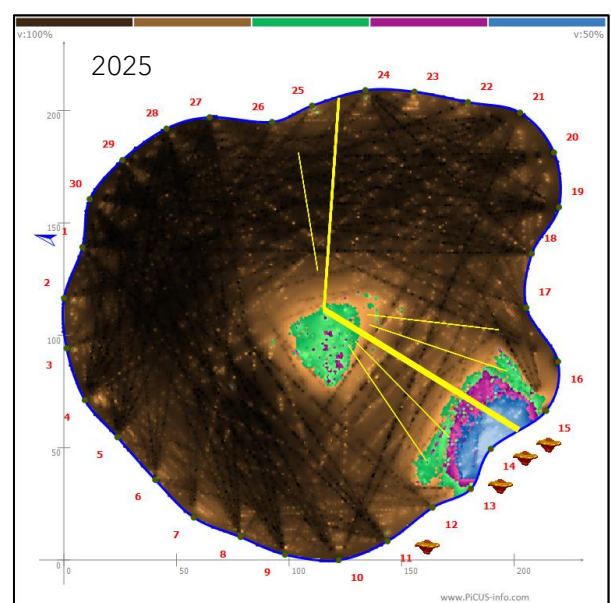
- The average diameter of the stem at the assessed level is c.225cm, with well-developed and heavily fluted buttress roots
- The two tomograms show decay is developing with the ERT result showing a larger area forming in the central area of the stem. This type of decay development is consistent with *Pseudoinonotus dryadeus* with the buttress roots remaining intact whilst the centre is decayed
- Compared to the 2021 assessment, the area of decay/hollowing has increased in size, but despite this, I do not consider the current extent is likely to affect the tree's structural condition and as such, it does not appear to require any further investigation at present

- I will however recommend the tree is reassessed in three years from the reports date so any further increase in the decay/hollowing can be mapped
