Annual Inspection Report

Lady Hope Play Area - RH14 0PX

Client:	Vita Play Limited
Address:	Unit A, Crest House, Salisbury Hill, Middle Wallop, SO20 8EG
Date:	27th November 2024
Inspector:	Jamie Haynes

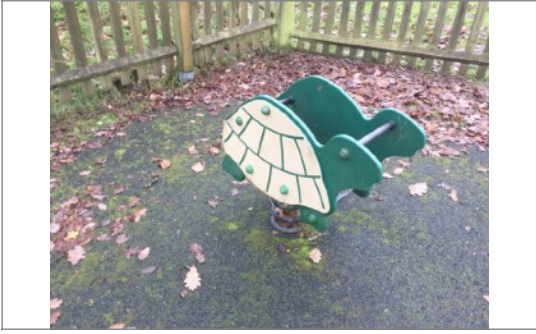
Item	Turtle Rocker				
Supplier	Wicksteed				
Surface	Wet Pour				
Risk Rating Overall	Very Low	Low	Medium	High	Unacceptable
		5

No faults found during the inspection.

5

Recommendation:
No action required, monitor this item.

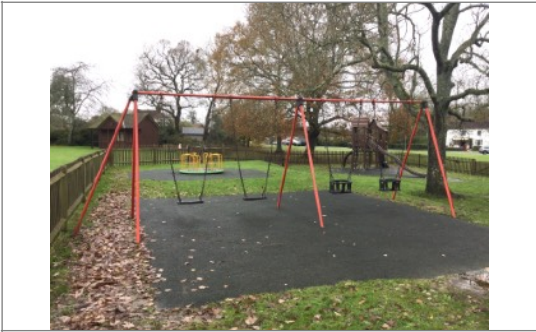
Item	2 Bay 2 Flat 2 Cradle Swing				
Supplier	Wicksteed				
Surface	Wet Pour				
Risk Rating Overall	Very Low	Low	Medium	High	Unacceptable
		7

Chain/connecting link(s) wear evident.

7

Recommendation:
Monitor to replace at 40% dia wear.

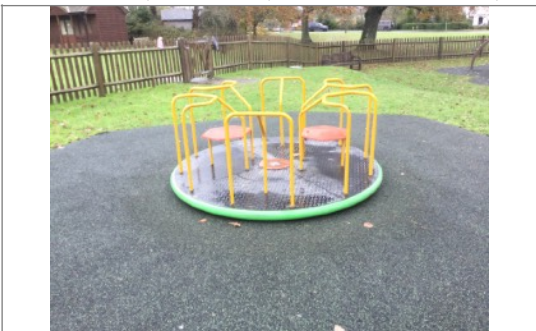
Item	Roundabout				
Supplier	Wicksteed				
Surface	Wet Pour				
Risk Rating Overall	Very Low	Low	Medium	High	Unacceptable
			8

Clearance between the underside of the roundabout and the surface is too low in places.

8

Recommendation:
Re-install unit or adjust surfacing to allow the recommended height of 60-100mm.

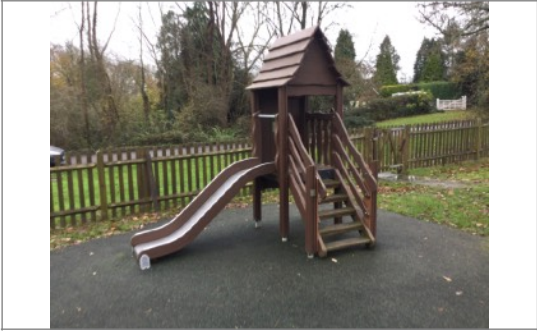
Item	Small Multiplay Unit				
Supplier	Lappset				
Surface	Wet Pour				
Risk Rating Overall	Very Low	Low	Medium	High	Unacceptable
		5

No faults found during the inspection.

5

Recommendation:
No action required, monitor this item.

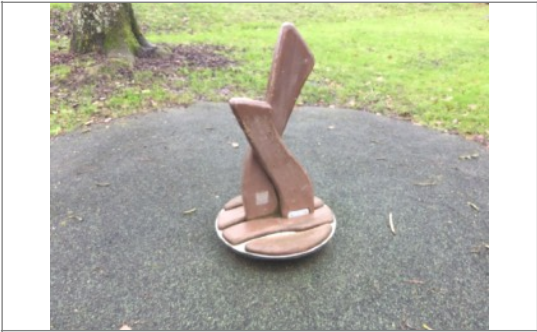
Item	Spinner Platform				
Supplier	Lappset				
Surface	Wet Pour				
Risk Rating Overall	Very Low	Low	Medium	High	Unacceptable
		5

No faults found during the inspection.

5

Recommendation:
No action required, monitor this item.

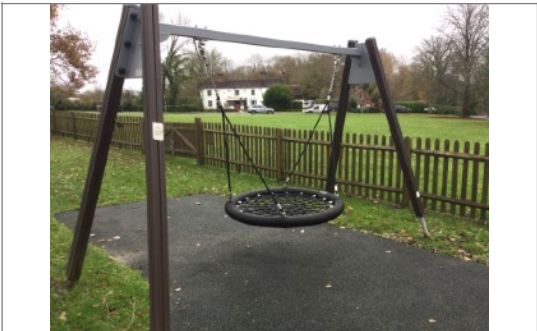
Item	Basket Swing				
Supplier	Lappset				
Surface	Wet Pour				
Risk Rating Overall	Very Low	Low	Medium	High	Unacceptable
		7

Worn bearing(s) evident.

7

Recommendation:
Monitor to replace bearings as required.

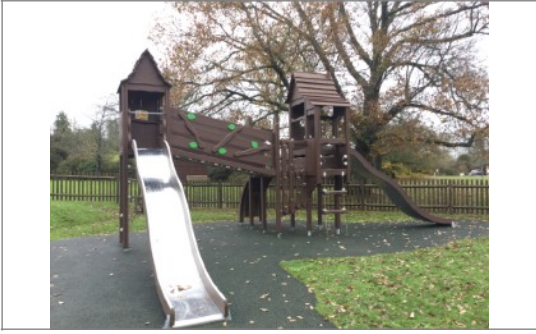
Item	Large Multiplay Unit				
Supplier	Lappset				
Surface	Wet Pour				
Risk Rating Overall	Very Low	Low	Medium	High	Unacceptable
		5

No faults found during the inspection.

5

Recommendation:
No action required, monitor this item.

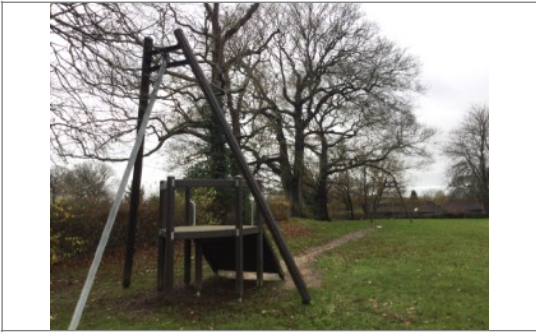
Item	Zip Line				
Supplier	Lappset				
Surface	Grass Matting				
Risk Rating Overall	Very Low	Low	Medium	High	Unacceptable
		6

Review recommended inspection and maintenance schedules as detailed from the supplier/manufacturer for zip line unit.

6

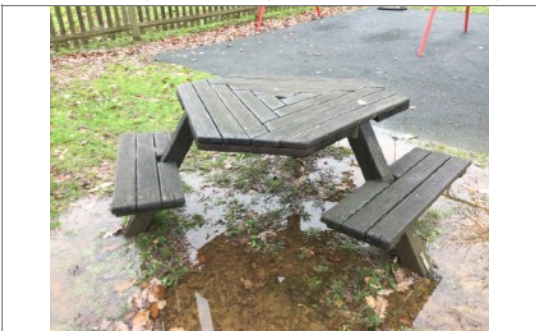
Item	Seating				
Supplier	Unknown				
Surface	N/a				
Risk Rating Overall	Very Low	Low	Medium	High	Unacceptable
		7

Most seating showing signs of decay.

7

Recommendation:
Consider replacing decayed seating.
